ODI RESUME

Investigation: EA 02-021
Prompted By: PE01-042
Date Opened: 09/06/2002 Date Closed: 11/06/2003
Principal Investigator: TOM BOWMAN
Subject: FRONT SUSPENSION U-BOLTS LOOSEN OR BREAK

Closing Report – EA02-021

Alleged Front Suspension U-bolt Failures (fracture, torque loss, stretching, or continuous loosening) in 1998 – 2003 model year (*) Volvo Truck North America (VTNA) VN Model Highway Tractors

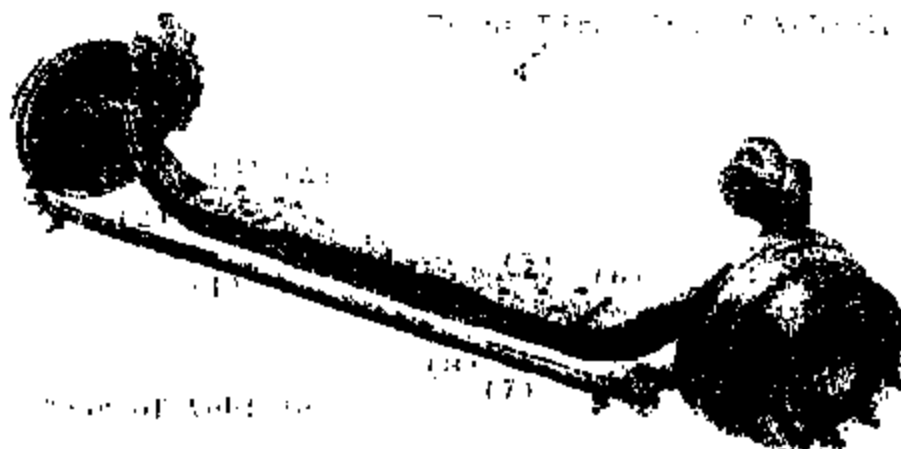
Sketch # 1

Using this sketch as reference, the table below the sketch summarizes the nature and direction of the damage observed at each of the eight front axle U-bolt holes.

U-Bolt Position in Front Axle	Corresponding Axle Beam Holes	Condition of Front Axle U-bolt bore
Left Rear U-bolt	# 1 - Inner Bore	No apparent damage to the bore
	# 2 - Outer Bore	A portion of a broken U-bolt remained in axle bore. See description and observations below.
Left Forward U-bolt	# 3 - Outer Bore	Material from the front axle bore had been displaced in the forward direction
	# 4 - Inner Bore	No apparent damage to the bore
Right Forward U-bolt	# 5 - Inner Bore	No apparent damage to the bore
	# 6 - Outer Bore	Major "lip" of material from the front axle bore material had been displaced in a direction 45 degrees right of forward
Right Rear U-bolt	# 7 Outer Bore	Minor "lip" of material from the front axle bore material had been displaced in a direction 45 degrees right of forward
	# 8 Inner Bore	No apparent damage

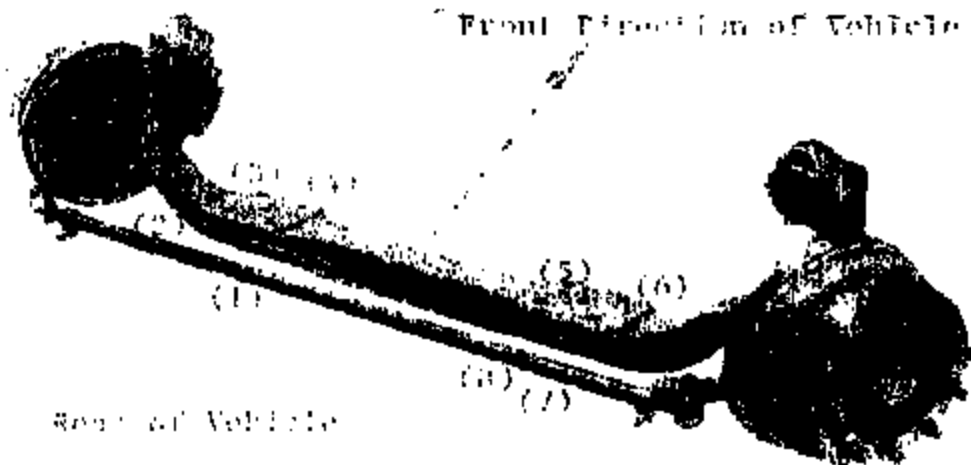
The sketch below identifies each U-bolt installation location by a number that corresponds to each of the front axle U-bolt mounting bores in a clockwise direction. The table summarizes the nature and direction of the damage observed at each of the eight front axle U-bolt bores.

U-Bolt Position in Front Axle	Corresponding Axle Beam Bores	Condition of the U-bolt and Front Axle U-bolt bore at the indicated position
Left Rear U-bolt	# 1 - Inner Bore	The bore is "open"; the small threaded fractured "stub" end of the U-bolt that had been installed through this bore is missing.
	# 2 - Outer Bore	The bent and fractured U-bolt was found "hanging" in its bore.
Left Forward U-bolt	# 3 - Outer Bore	The bore is "open" - The U-bolt is missing from the axle.
	# 4 - Inner Bore	The bore is "open" - the U-bolt is missing from the axle.
